**Flood Control Project Maintenance
Levee Inspections**
LMA District Cover Sheet
Spring 2018 Levee Inspection Results

Sacramento Maintenance Yard Maintenance Area 0009

Spring 2018 Levee Inspection Results

Waterway	Bank	Unit Miles
Unit No. 01 Sacramento River	Left	19.35

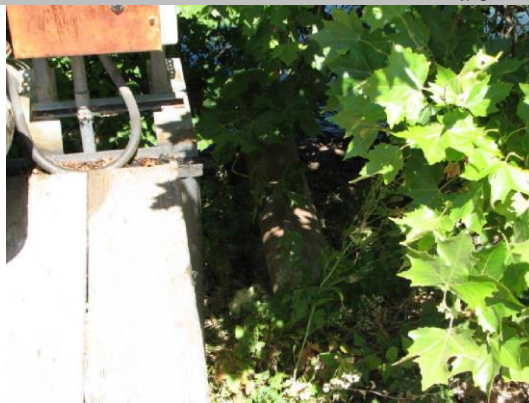
Photo 3 of 3 : UCIP_SP_2018_5783_8752.jpg

Item	DWR UCIP Field Study			38.350460 °	38.350460 °	
				-121.532600 °	-121.532600 °	
DWR ID						
Comment Code						
Inspector Comment						
FS_ID:5783 DS_ID:17451 EP_NO: N/A Repair Type: Non-Urgent Crossing Status: Found UCIP Comments: Oil leaking all over pump platform and ground around pump. CMP riser on LS slope is damaged and should be marked to prevent further damage of siphon breaker and roadway equipment. FIELD_STRUCT_DESC: 12-inch pipe through levee, 4.5 feet below crown. Slant Pump on pile structure on WS slope. Siphon breaker on landward slope. 1.5-inch galvanized electrical conduit 4.5-feet below the crown from JP on LS toe to Breaker on slant pump pier. 36-inch Concrete standpipe on LS toe. One cm cutoff wall. Originally included in O+M manual (1955). FS Date: 7/25/2012 3:15:00 PM

Pipe below structure on upstream side of slantpump.

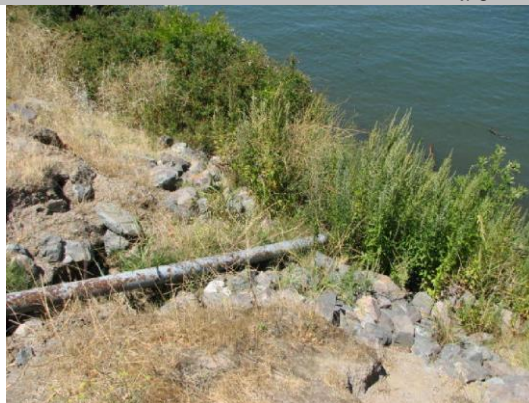
Photo 3 of 3 : UCIP_SP_2018_5943_9074.jpg

LM Start	19.13	Rating **	M	Issue No.	1857 (cont)	
LM End	19.13	Issue Type +	En	Location *		
Category	Supplemental			GPS Latitude/Longitude		
				Start		End
Item	DWR UCIP Field Study			38.349330 °		38.349330 °
				-121.533830 °		-121.533830 °
DWR ID						
Comment Code						
Inspector Comment						
FS_ID:5943 DS_ID:17477 EP_NO: N/A Repair Type: Non-Urgent Crossing Status: Found UCIP Comments: This pipe is a good candidate for video inspection. headwall is cracked and generally looking in poor repair. This may need some work. FIELD_STRUCT_DESC: 10-inch pipe through levee, 3.0 feet below crown. Pump on concrete pad waterward slope with a siphon breaker in a 12-inch steel riser on the LS shoulder and a shutoff valve on the WS shoulder. Service pole on landward slope. Originally included in O+M manual as a 3-inch pipe(1955). FS Date: 7/25/2012 3:45:00 PM

suction pipe on WS slope.
